MAINTENANCE/MANAGEMENT PLANNING AND FIELD INVESTIGATION INSTANCES FOR STEEL-CONCRETE COMPOSITE SLABS

Tadayuki Noro, Nobuhiko Hayashi, Kohji Kira, Takashi Ishikawa, Yasuhiko Doi

*Japan Bridge Association,
2-2-18 Ginza Chuou-ku Tokyo, Japan
noro.tadayuki@eng.nsc.co.jp*

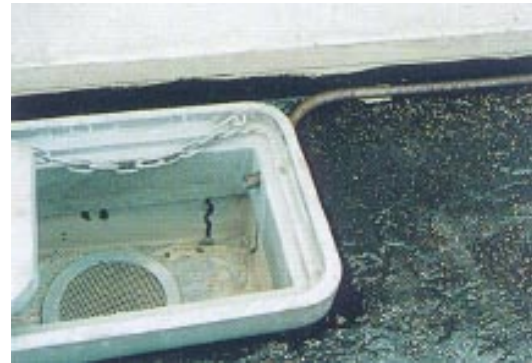
It is hard for composite slabs to drain water completely once it penetrates into them since their bottom faces are covered by the bottom steel plate. For this reason, basically, zinc-rich primer is applied to the face in contact with the concrete on the inner surface of steel plate panels, and when freezing protectant product or snow melting agent is scattered in cold regions, etc., the materials issued from hot-dip galvanizing or polymer cement of thick film and the like are applied to the inner face of steel plate panels. On the other hand, the same coating as that for steel girders or hot-dipped galvanizing, metal spraying or the same specification as that for anti-weathering steel materials is applied to the lower face of bottom steel plate. In addition, concreting joints between the slab concrete and a central island or a wheel guard portion are executed carefully, and counter-measures against water bearing such as the placement of water-proof layers, the arrangement of drainage gradient along vertically crossing direction on the top surface of slabs, the disposition of water conduits as shown in Photo.2 within the pavement are taken into consideration.

Photo 2. Water conduit within a pavement

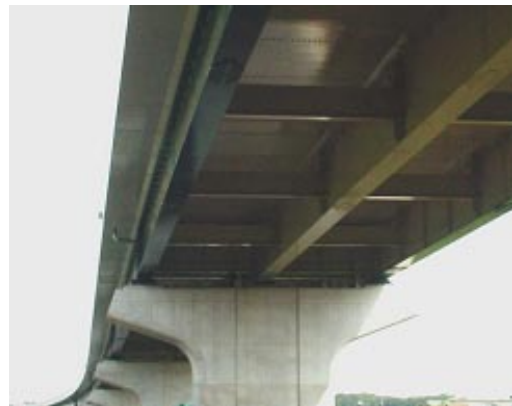
The visual observation of the condition on the pavement surface is conducted as a first step of the inspection, since any behavioral change becomes frequently visible when the degradation of concrete proceeds. In addition, it is desirable to verify if there is any leakage water concerning the bottom steel plate face, or not, by visual inspection as shown in Photo.3, and when any behavioral change is noticed, it is preferable to conduct simple measurement in order to evaluate the behavioral change quantitatively by length, area and the like using a tape measure etc. On the other hand, it is preferable to conduct the impact acoustics testing (hammering) using a test hammer as shown in Photo.4 against the swell-up of bottom steel plates or the behavioral change of panel joint bolts to grasp their situation.

Photo 3. Visual observation

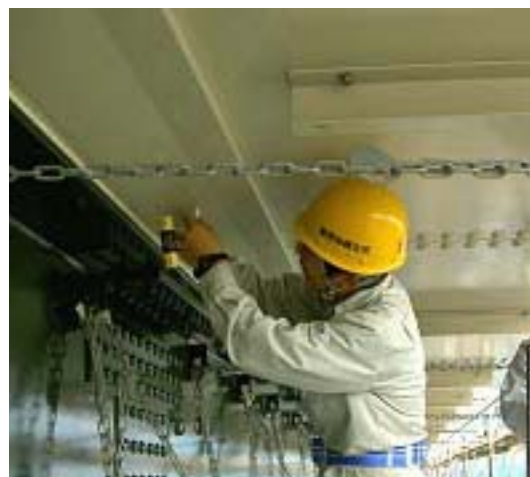
A test using non-destructive inspection equipment may be conducted when sufficient information can be obtained neither by visual observation nor by impact acoustics testing (hammering) alone. When the test using non-destructive inspection equipment is conducted, it is necessary to clarify the purpose, the applied scope, and the precision needed for measurement to select suitable equipment.

Photo 4. Hammering testing

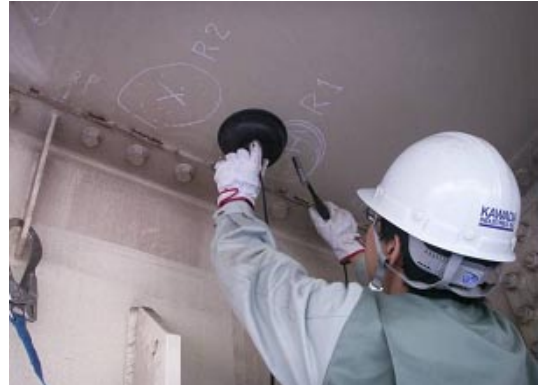
Conventionally, the methods such as the Penetrant Testing (PT), Magnet Particle Testing (MT), and Ultrasonic Testing (UT) for detecting cracks in a steel material are typical, and the measurement method using an ultrasonic thickness meter for the thickness measurement of bottom steel plates is applicable. Furthermore, as the diagnosis of the soundness of concrete structures by non-destructive testing, there are Acoustic Emission (AE) method, ultrasonic method, rebound hardness method, electromagnetic induction method, natural potential measurement method, ultra-red thermography method, etc., any of them is supposed to be applicable. Moreover, from the standpoint of working performance at field sites, the impact acoustics testing method²⁾ (Photo.5) analyzing collected sound reflecting from the slab struck by an impulse hammer, and the elastic sweep wave method (Photo.6) performing the frequency analysis of reflected waves excited on the bottom surface of composite slabs by a probe generating the elastic sweep wave of frequency of 9-16 kHz are supposed to be particularly effective.

Photo 5. Impact acoustics testing method

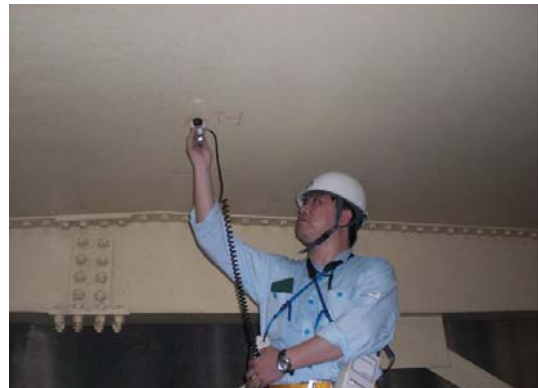
Photo 6. Elastic sweep wave method

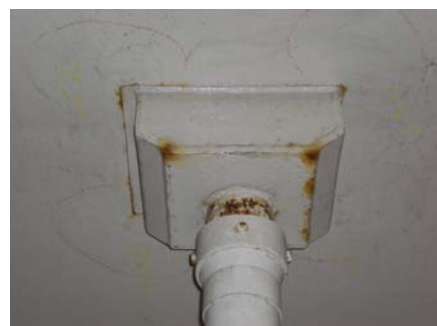
Photo 8 Aspect of around a drainage box
